## Summary of inspection report of fire along *De Kelders* in Leeuwarden, 19 October 2013

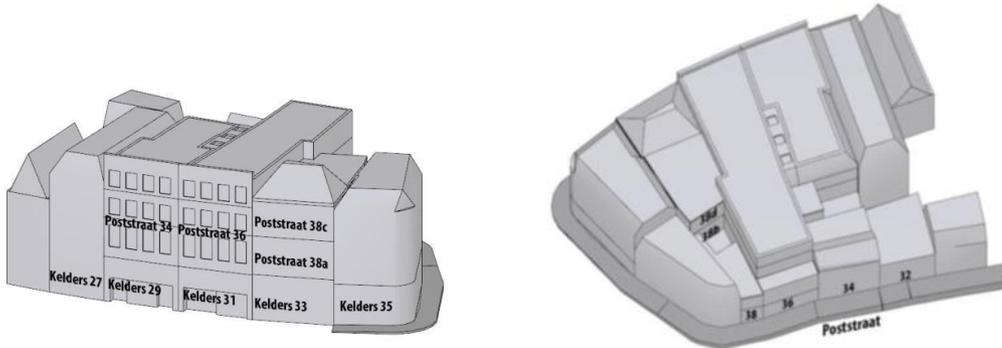
Illustration 1: Positioning of the premises and addresses in respect of each other (drawing: Tjalling Graafsma).
