Summary of inspection report of fire along *De Kelders* in Leeuwarden, 19 October 2013

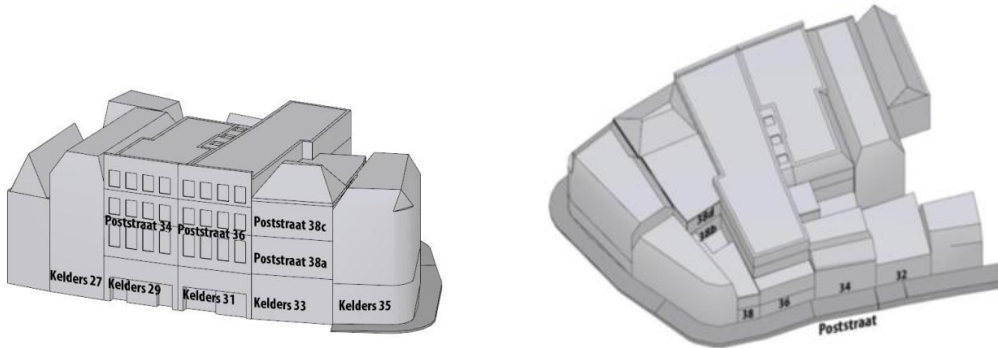
Illustration 1: Positioning of the premises and addresses in respect of each other (drawing: Tjalling Graafsma).

On Saturday 19 October 2013 at 17:21 hours the Incident Room for North Netherlands received a call about a fire in the Freestyle clothing store situated at 31 De Kelders in the old inner city of Leeuwarden. The adjacent premises contain, amongst other things, a clothing store and a hairdressing salon on the ground floor. Residences are situated above all these premises.
